Primary and Contributing Causes of the Loss of Primary Function of the Jones Ferry Road Water Treatment Plant

PREPARED FOR: Ed Kerwin, Executive Director
Orange Water and Sewer Authority

PREPARED BY: CH2M HILL North Carolina, Inc.
JD Solomon, PE (NC# 18650)

DATE: February 10, 2017

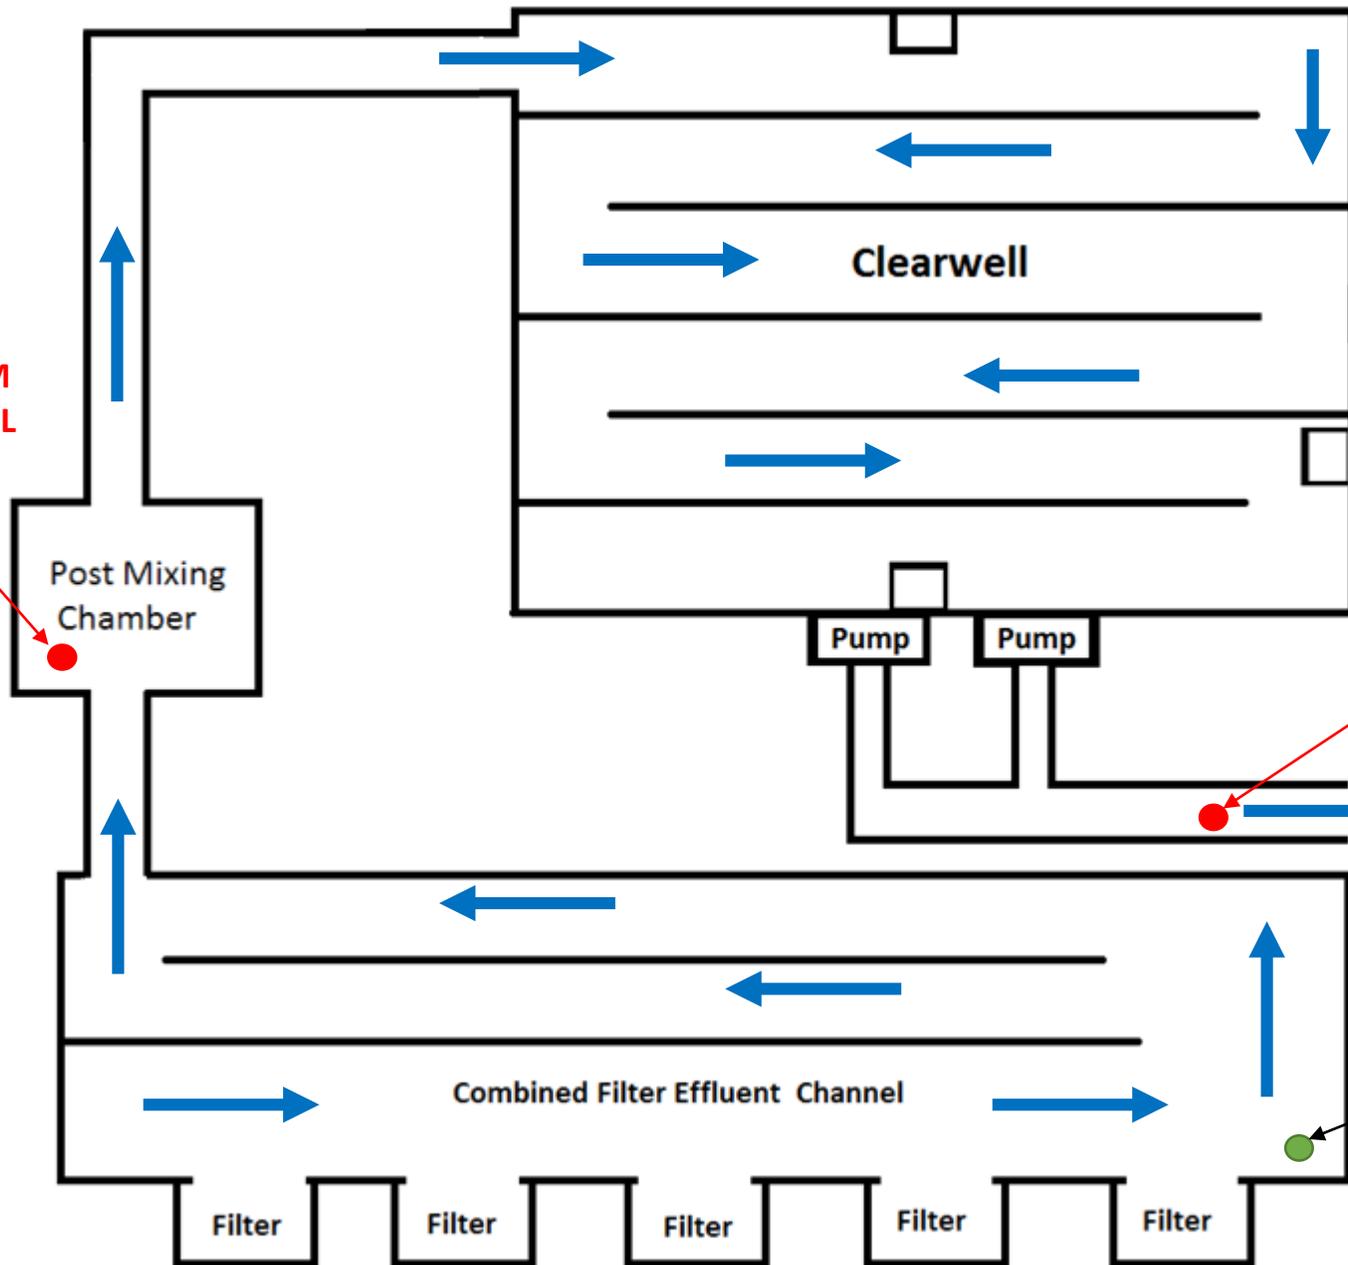
Appendix A
Sampling Location Schematic

**Filtered Water
Sampling Point**
2/2/17 @ ≈ 3:10 PM
Fluoride = 5.90 mg/L

**Finished Water
Sampling Point**
2/2/17 @ ≈ 3:10 PM
Fluoride = 0.68 mg/L

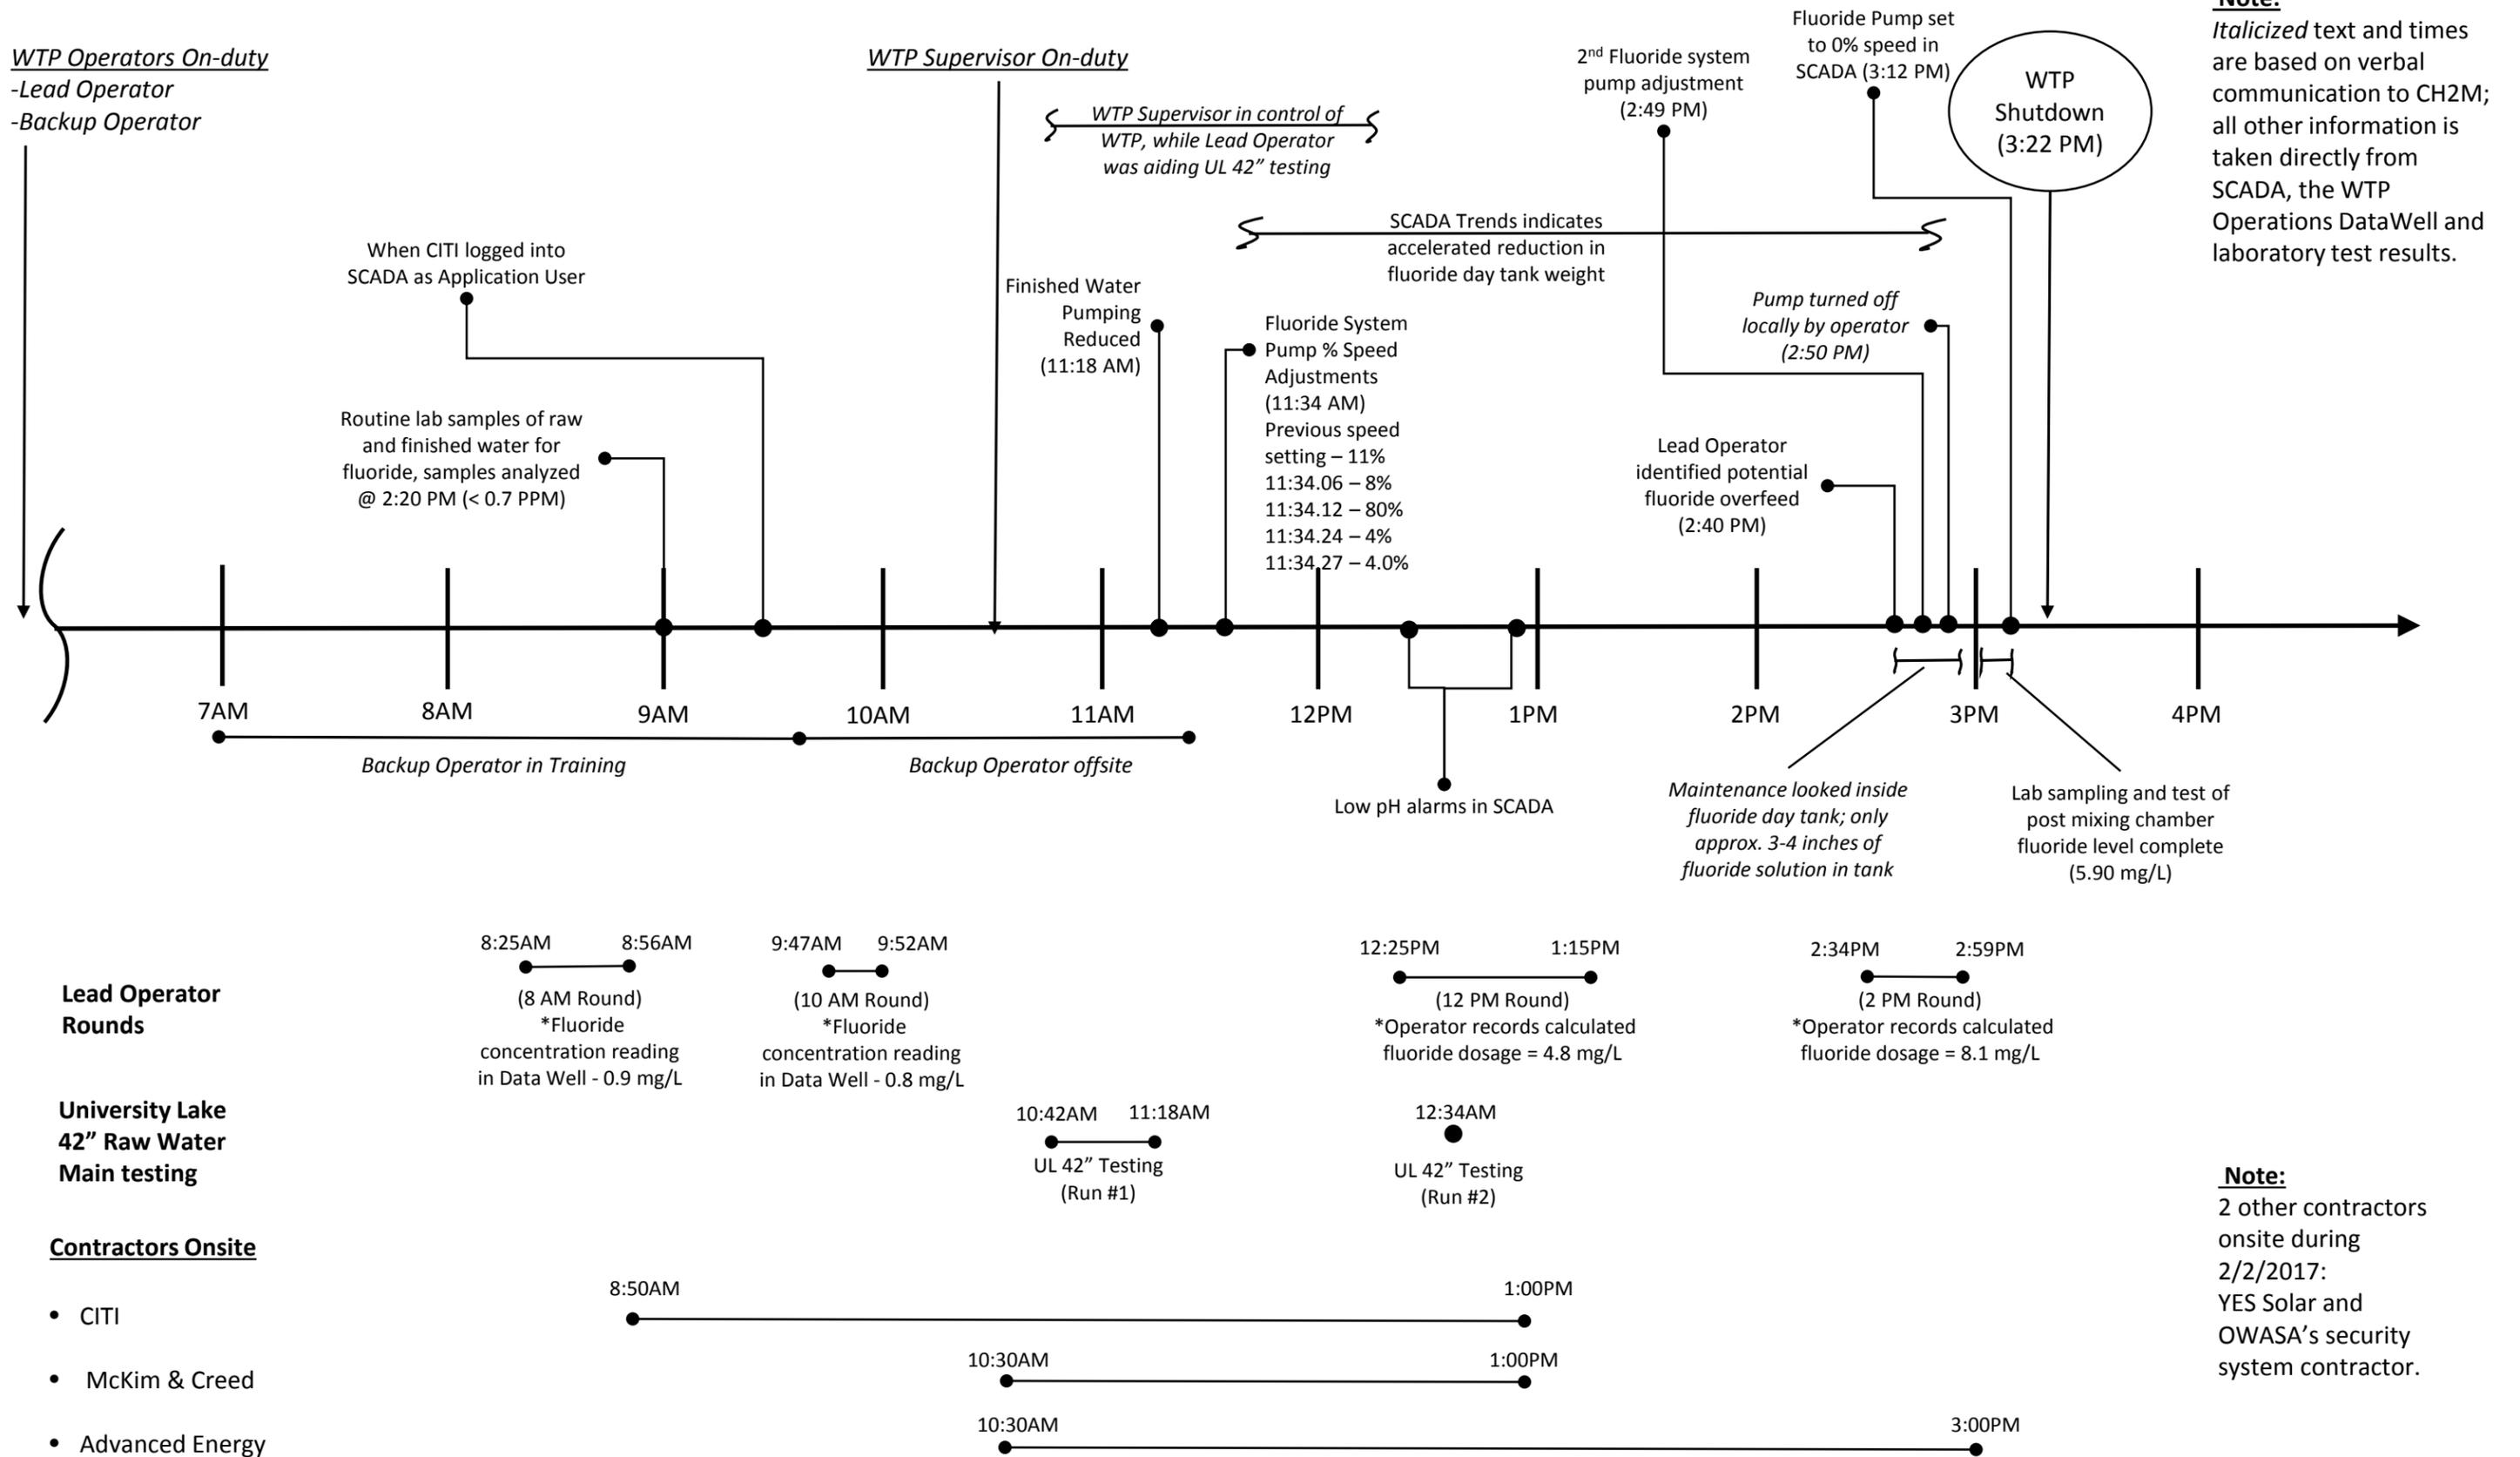
Jones Ferry Road WTP Shutdown – February 2, 2017 Timeline

- 10:42 AM - Raw water flow testing begins with varying raw water flows to WTP
- 11:34 AM - Fluoride system pump adjustments made by Supervisor in response to varying flow rate, fluoride day tank drawdown rate significantly increases
- 2:40 PM - Potential fluoride overfeed identified by Lead Operator
- 3:10 PM - Laboratory sampling and test results from OWASA's certified laboratory confirm elevated fluoride levels
- 3:22 PM - WTP shut down
